# Manhole Inspection Summary

Manhole # S11MM\_037MH

Insp Date: **1/21/09 11:33 AM**

**Location** Address: **POPLAR TER**

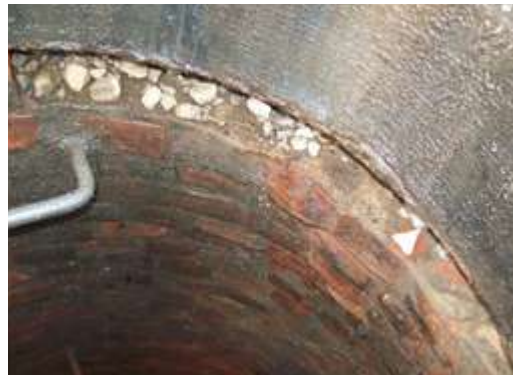
Defect 1

Condition: ☐ Sound ☒ **Cracked** ☐ Root Intrusion ☐ Loose Brick ☒ **Deteriorated**

CRACKED AND DETERIORATED  
CHIMNEY

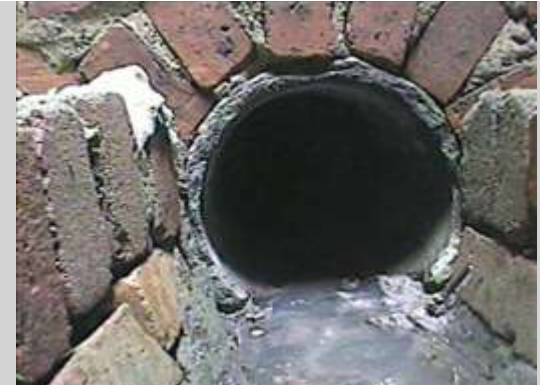
12 O'Clock Outflow

8 in. Circular Gravity Sewer  
Pipe Out @ 12 O'Clock

DEBRIS IN CHANNEL AND ON BENCH

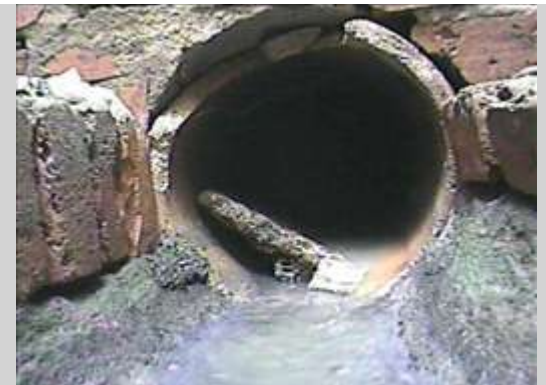
6 O'Clock Inflow

8 in. Circular Gravity Sewer  
Pipe In @ 6 O'Clock

Pipe Height: (in.) Direct  
Pipe Material: **Clay** ☐ Pipe Lined  
Invert Depth: **6.15** (ft.) Flow Characteristics: **Slow**  
Deposits: ☒ None ☐ Mud ☐ Sludge ☐ Debris ☐ Grease  
Silt Depth: (in.) Deposits Extent:  
Infiltration: **None** Pipe Seal Cond: **Broken**
